Atari Technical Bulletin
Number: TT30-0005
Date: April 2, 1992
Page 1 of 2

Product(s) Affected: TT030
Model: All
Type of ATB: As Needed
ECO #: 1428

To reduce noise and jitter seen on the high resolution monitor.

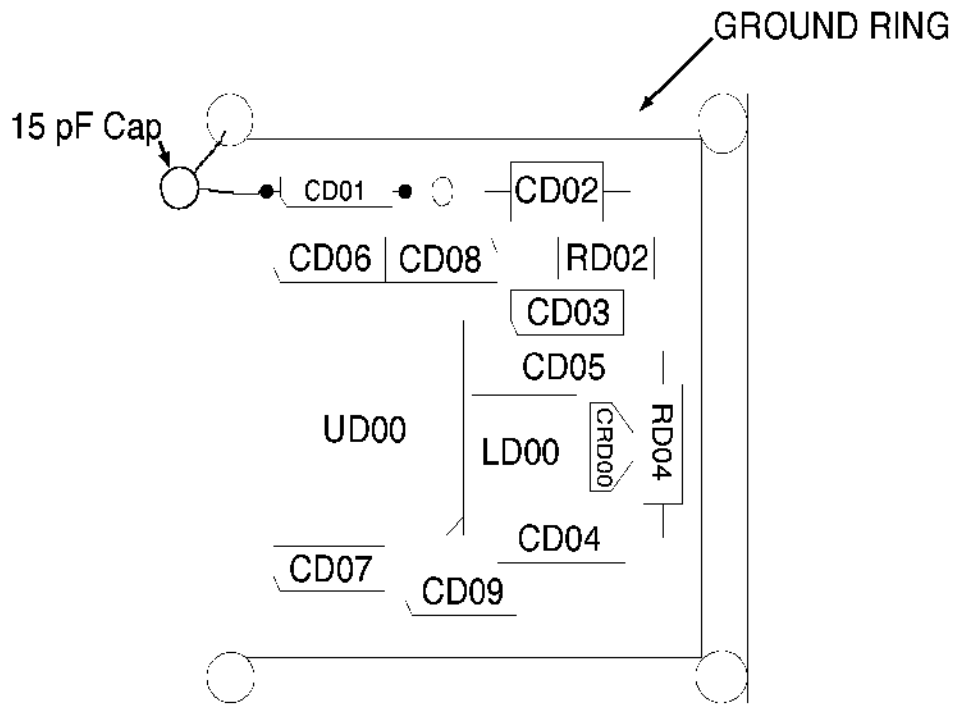
Video jitter on high resolution TT Monitor.

1. Remove the top cover of the TT030.
2. Remove the VME Card Guide.
3. Locate the 8530 circuit. See Figure 1 on page 2.
4. Connect a 15pF capacitor from the left side of CD01 to the top left corner of the ground ring. See Figure 1 on page 2.
5. Re-assemble the unit.
